## General Manager's Report August 23, 2010

# FRIENDS OF LIGHT RAIL & TRANSIT'S

2009/10 State of the System Report

# EXECUTIVE SUMMARY

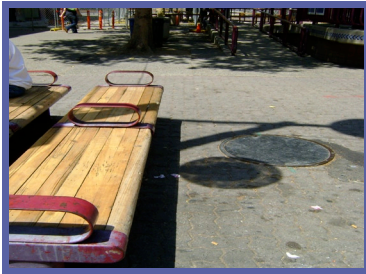
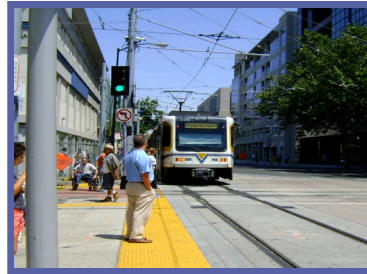
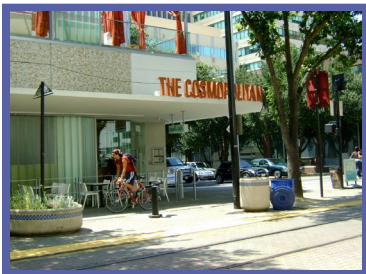
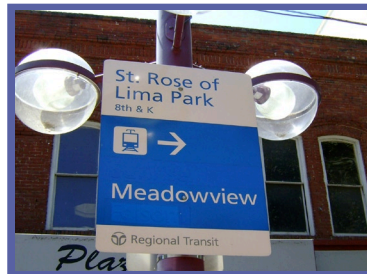
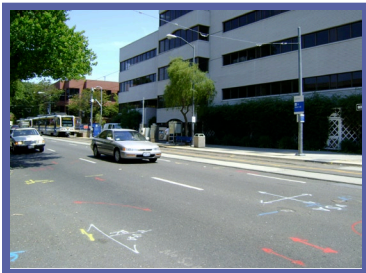
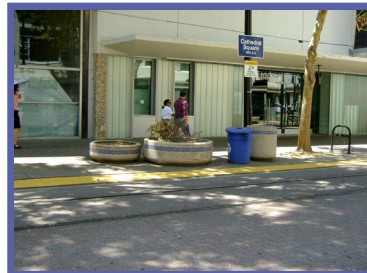
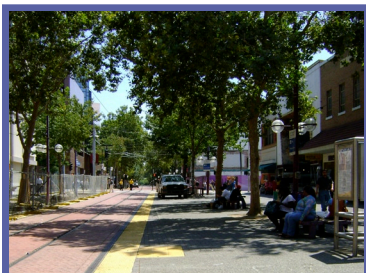
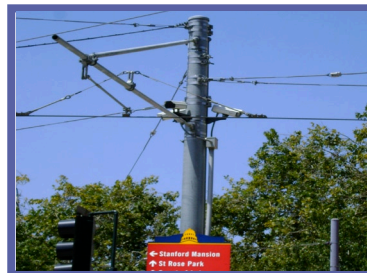
Cameras are visible, but do they function? Some construction during the station tours provided some disruption (to be expected). This portion of the light rail line should be the model for new signage and ridership information. Although most of the fare machines were in good order, they are still old fare machines (see general recommendations at the end of this report). These stations present challenges, being on a pedestrian, retail oriented corridor. Trees are needed for shade as riders wait for trains. Trees, however, will block retail signage and need maintenance (city?).

*Photos above show the K Street area stations, their amenities and current conditions.*

Pavement improvements needed (wear and tear issues). Lighting should be reviewed in greater detail to be consistent and supportive of the Downtown Partnership's Guide Program objectives. Additional public art is needed at these stations.

Replace landscaping. Benches should be converted to new bench style, and more benches should be added to the corridor. Directional signage could be improved (to bus routes, sites, etc.) and route information displayed in a different way.

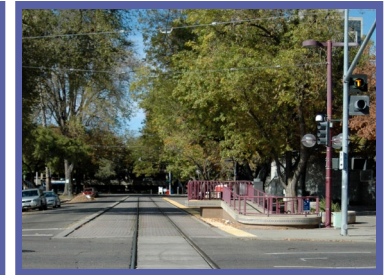
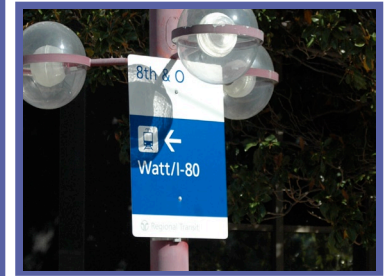
Nighttime lighting and signage in question. Golden One on site.

Photos above of the 8th/O and Archives Plaza Stations - both stations are very similar to each other.

Add a bicycle rack and trash can replacement.

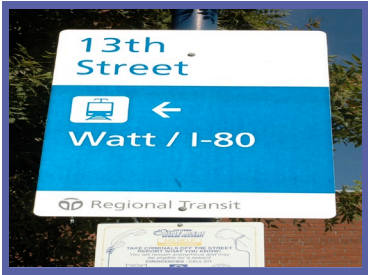
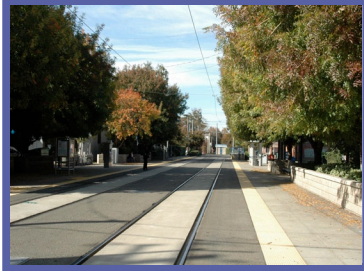
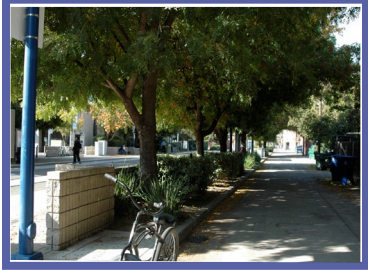
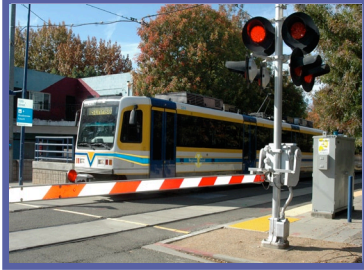
Like the many of the other downtown area stations, there really isn't much to this station. It has an interface with the streets on three sides and a number of "hidden" areas that may present safety hazards and maintenance problems.

Remove low "seat" walls and replace landscaping (except trees).

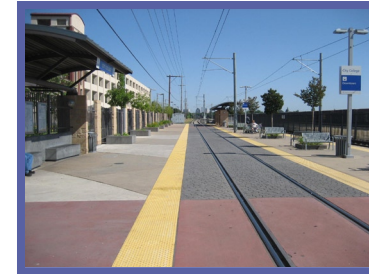
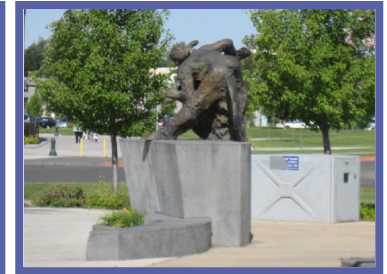
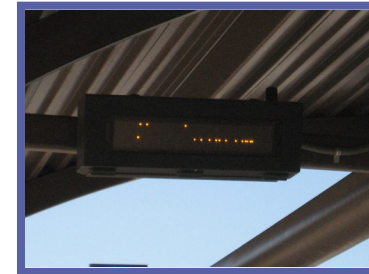
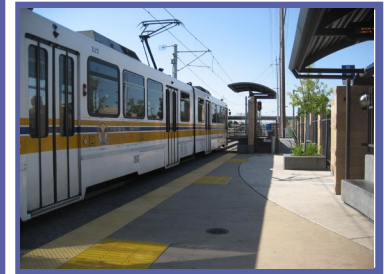
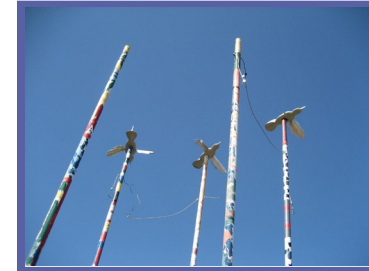
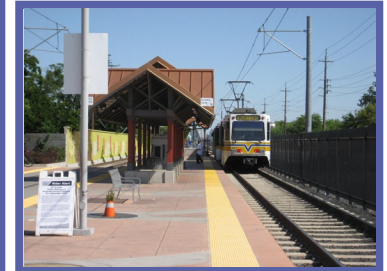
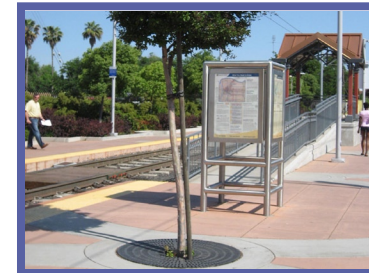
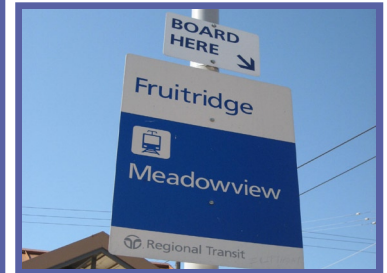
This is another neighborhood station and it is in fair condition. There are some areas that are very "hidden" from the street, and probably not safe. Public art is damaged or broken. Plants have been removed but not replaced. In general, attractive pavement and structures.

Photos above show the City College and Fruitridge Stations, including the damaged art at Fruitridge (on left, second from bottom).

Move bike parking to street side of station. Replace trees.

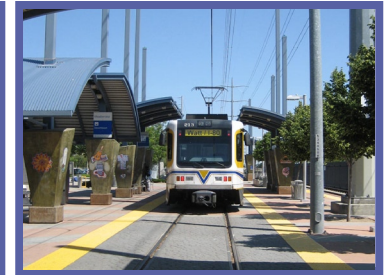
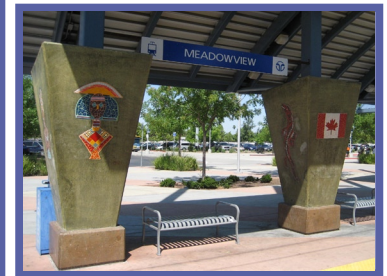
Lots of apparent loitering and a very passive security patrol gave the perception that the station was full of users. Smoking, loitering and panhandling seemed to be permitted at the station. We counted the most cameras of any location in the system at this station: six. There are not many supportive businesses nearby.

*The four photos above depict the Meadowview Station (the end of the Southline).*

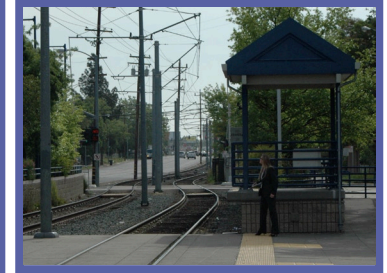
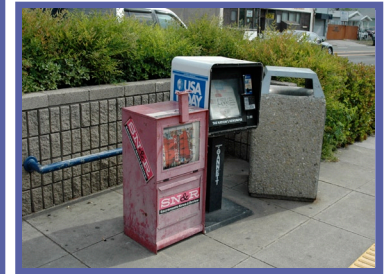
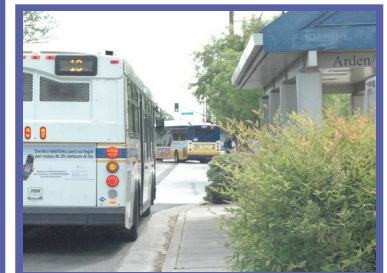
The parking lot was full (only 45 spaces). Strong security presence on the station platform. Tour team had lengthy conversations with security personnel on this leg of the tour, in particular at the Arden/Del Paso station. It sounds like there have been few issues in the past year, but historically the station had a major drug trafficking problem. Given the layout of the station (parking lot, adjacent to a park, etc.) this is conceivable. Finally the ongoing problem of urination and defecation at the station (and on adjacent properties) continues.

All photos above are of the Arden/Del Paso Station. Contrasting images show large pedestrian walkways on portions of the station area (upper left) and encroaching vegetation (bottom right).

The east end of the station continues (despite recent improvements) to have an awkward interface with the roadway. This safety hazard should be addressed long term. There are also a number of properties in the immediate area that would be good TOD sites, this should continue to be promoted. All landscaping design should be studied in greater detail (plenty of areas that could serve as stash spots or make-shift restrooms).

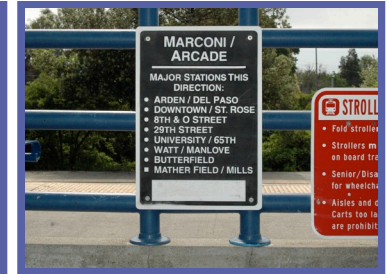
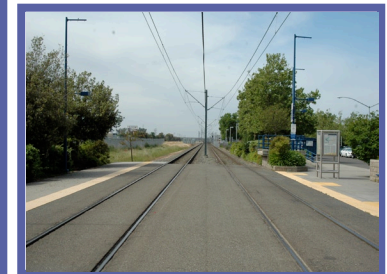
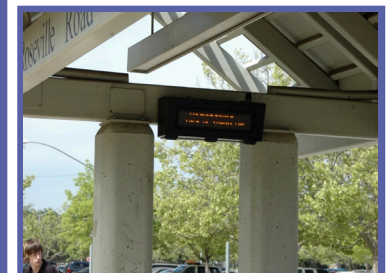
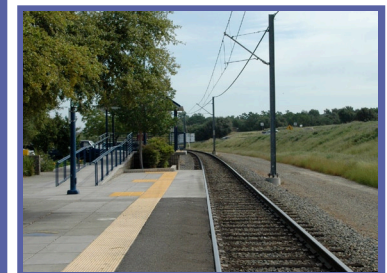
Quiet station with multiple security guards (why?). We heard that speeding in the parking lot is one of the biggest challenges. Electronic sign working (but just showing time of day).

Top photos from the Marconi Station, the bottom four photos from the Roseville Road Station. Photo, second from bottom on the right, shows one of only a few electronic reader boards in the system (showing time only).

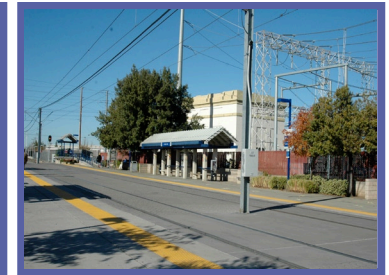
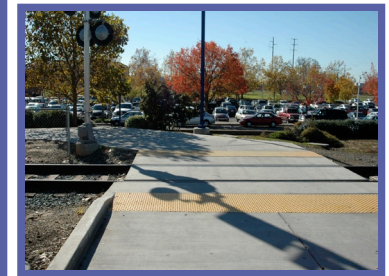
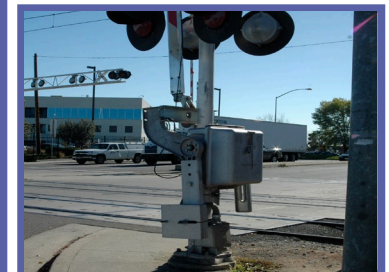
This station is located near office, retail and a neighborhood. Transition to the office (south) is good, Folsom Blvd. presents a safety hazard. Old design (what are those horizontal bars for anyway - middle left photo).

*Top four photos show the newer Power Inn Station, with the older College Greens Station below.*

More shade (covered seating). Fence repairs needed. More bike racks.

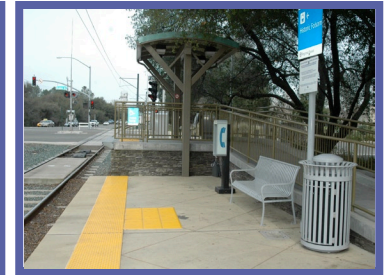
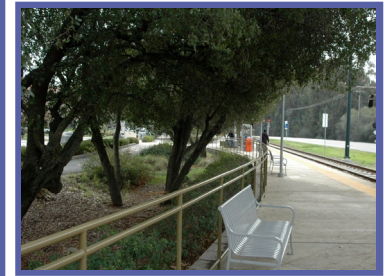
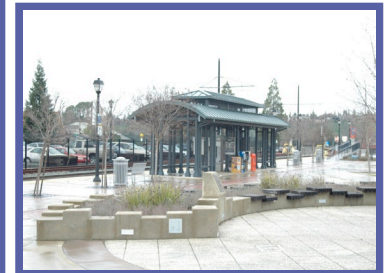
*Pretty nitpicky to point out the unfinished electrical connections and brick work (bottom left), but there is little to criticize at the Historic Folsom Station. The Glenn Station speaks for itself (top four photos).*
