## General Manager's Report August 23, 2010

# FRIENDS OF LIGHT RAIL & TRANSIT'S

2009/10 State of the System Report

# EXECUTIVE SUMMARY

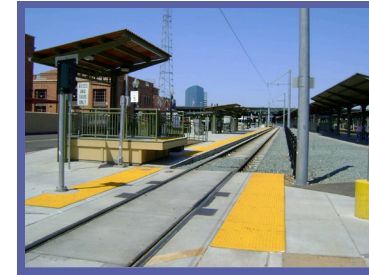
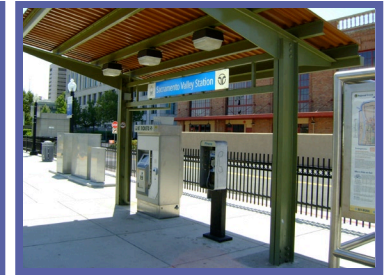
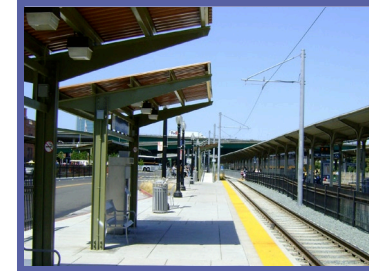
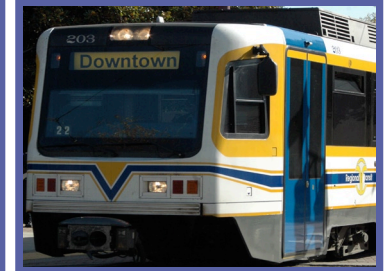
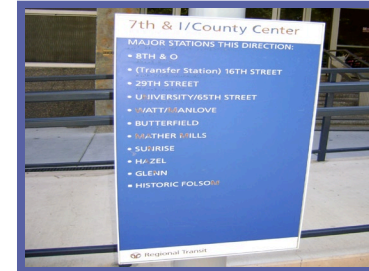
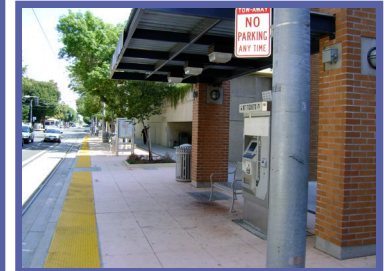
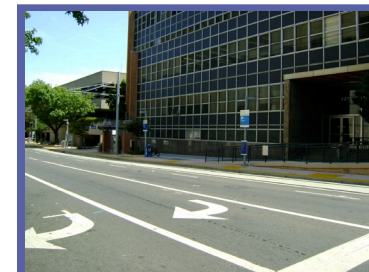
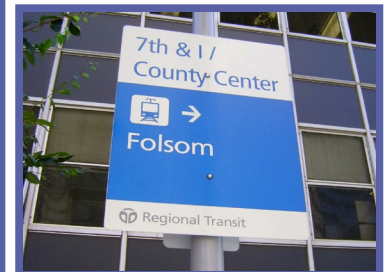
Nighttime lighting is not ideal and there are no amenities.

Four top photos of Sacramento Valley Station, bottom four photos show 7th/I Station.

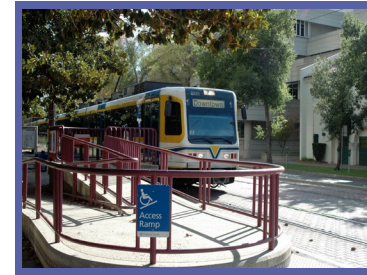
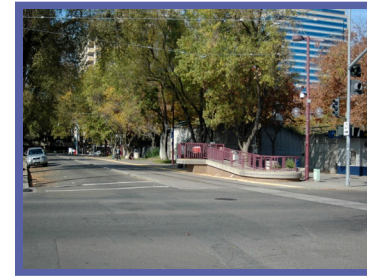
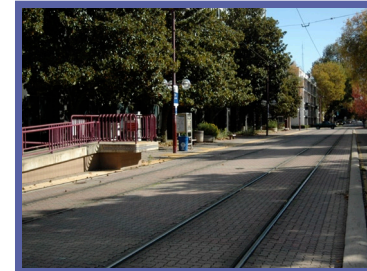
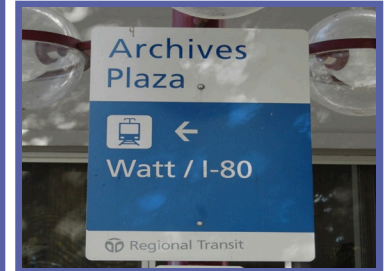
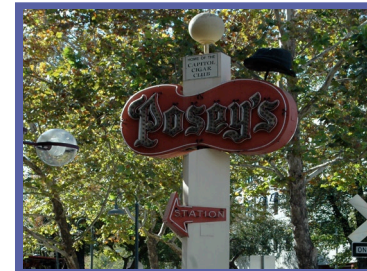
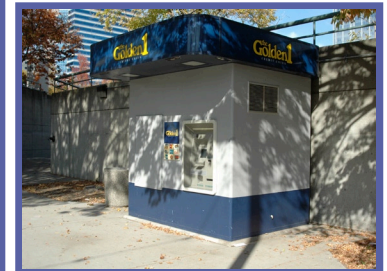
Nighttime lighting and signage in question. Golden One on site.

Photos above of the 8th/O and Archives Plaza Stations - both stations are very similar to each other.

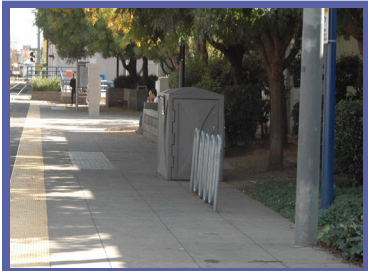
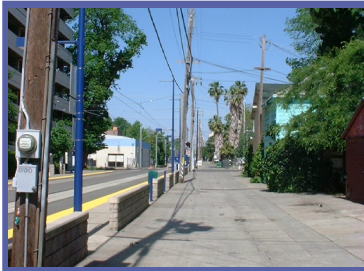
Some bike parking (needs more). No amenities.

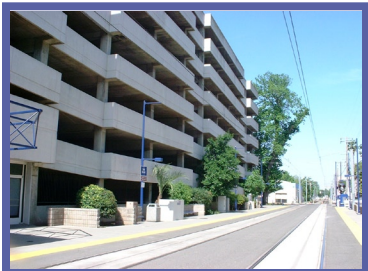
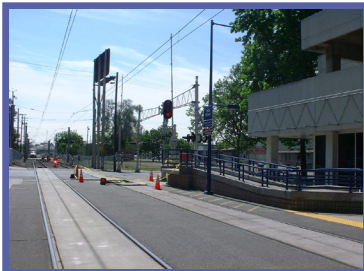
Nighttime lighting and signage in question. Strong security presence. More sitting areas needed.

*Photos above show the 13th and 16th Street Stations.*

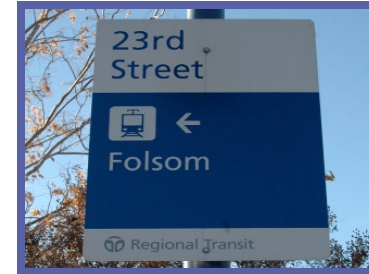
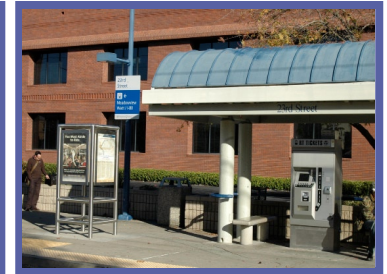
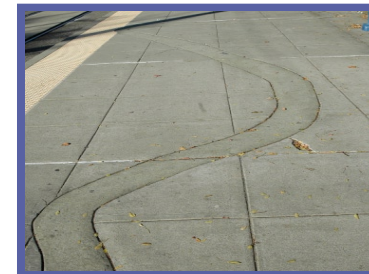
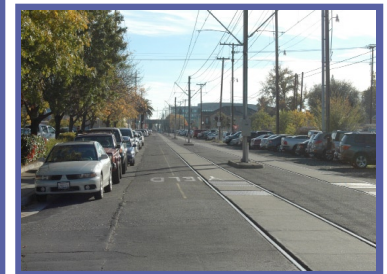
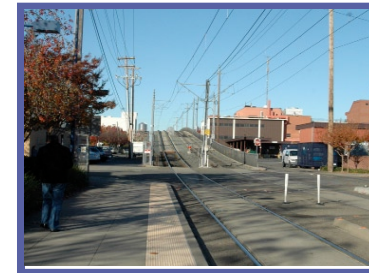
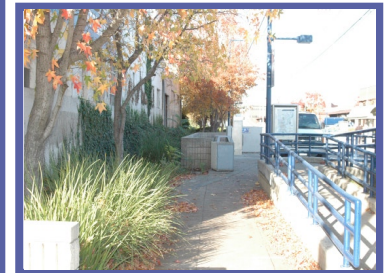
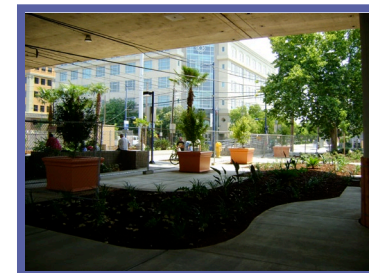
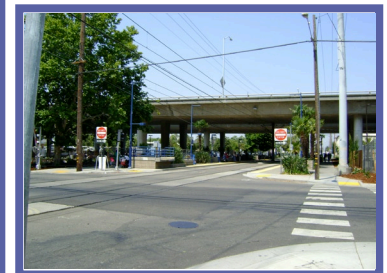
This is an important station in the system, connecting with many large employers (including RT). There will be additional opportunities for improvements (new programs) and this is a good test site for those new concepts.

*The top six photos above show the 23rd Street Station and the bottom two photos show the 29th Street Station. 29th Street recently received some enhancements as a part of a pilot program.*

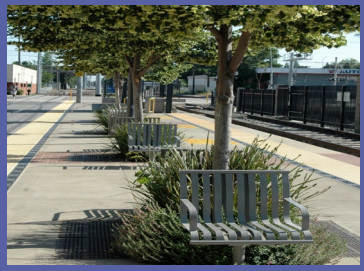
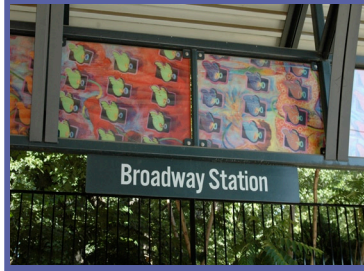
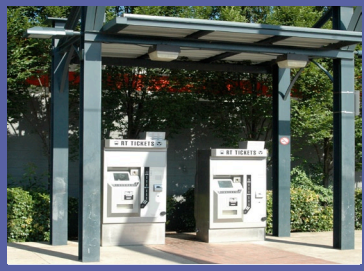
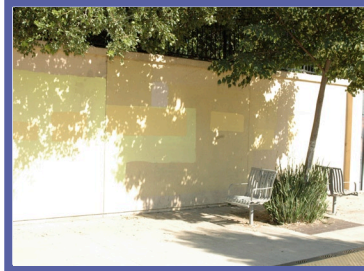
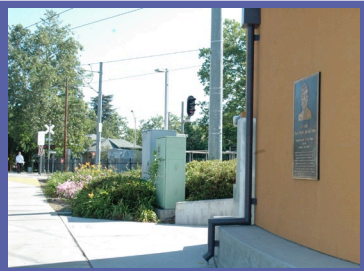
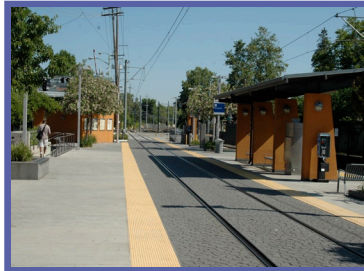
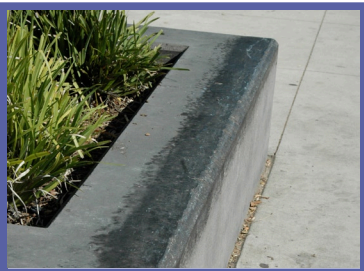
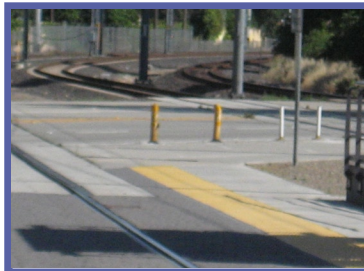
Broadway - 4th Avenue/Wayne Hultgren  
Toured on May 29, 2009

Strong security presence. More sitting areas are provided. Some user (skateboarder) damage.

*Photos above show Broadway and 4th Avenue conditions, in particular, the pedestrian conflicts (bottom right) and the planter damage (bottom left).*

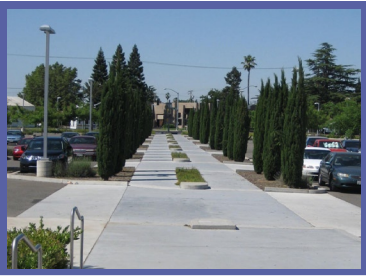
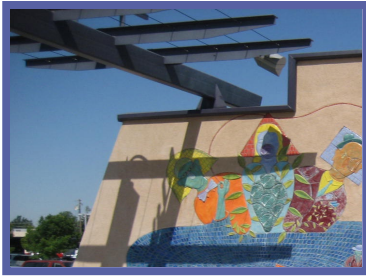
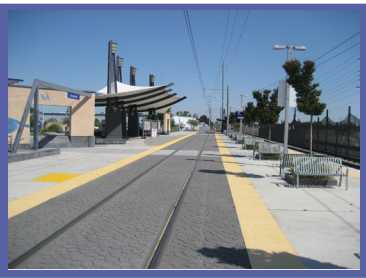
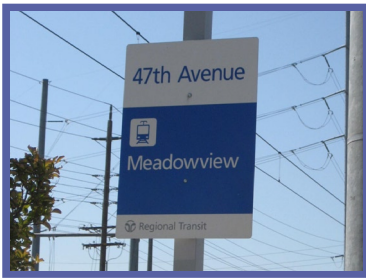
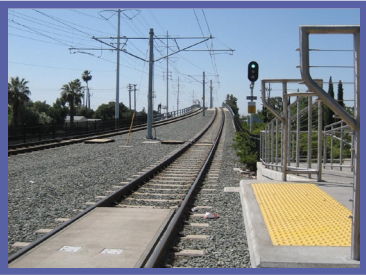
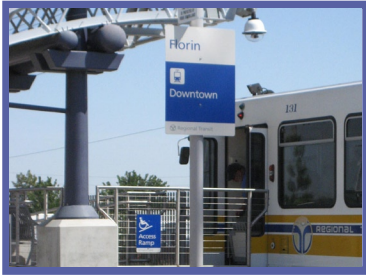
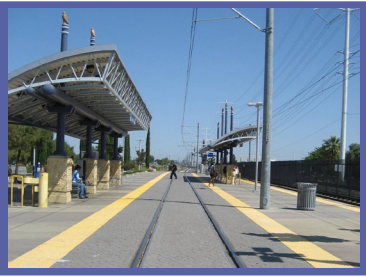
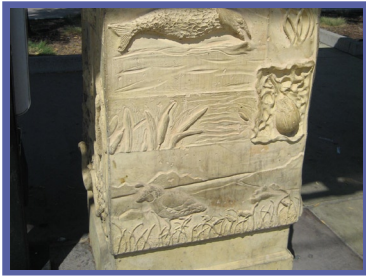
## 47th Avenue - Florin Road

Attractive station that successfully integrates parking into the station area. The station has plenty of seating and covered area (shade for riders).

A little unclear on what side to exit the train. Parking lot about two thirds full. Active security guard (greeting people, giving change to riders, etc.). Pavement, structures and public art in good condition.

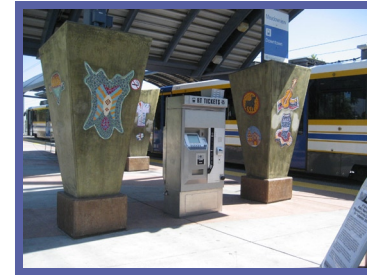
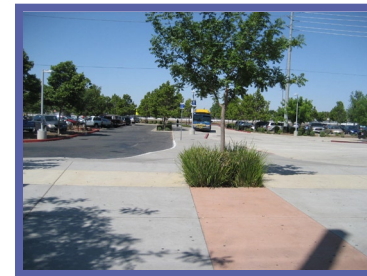
Lots of apparent loitering and a very passive security patrol gave the perception that the station was full of users. Smoking, loitering and panhandling seemed to be permitted at the station. We counted the most cameras of any location in the system at this station: six. There are not many supportive businesses nearby.

*The four photos above depict the Meadowview Station (the end of the Southline).*

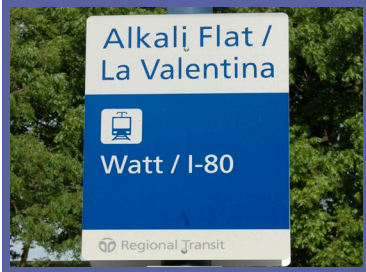
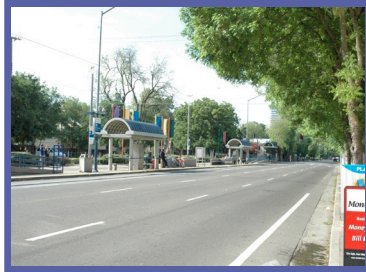
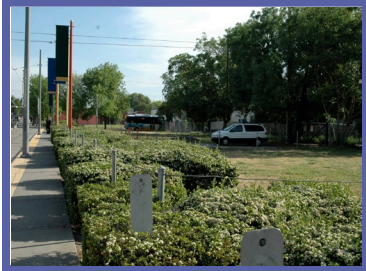
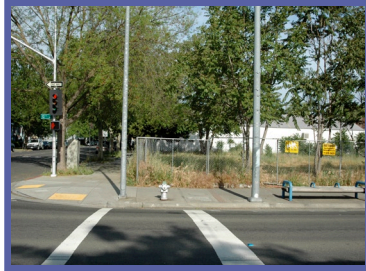
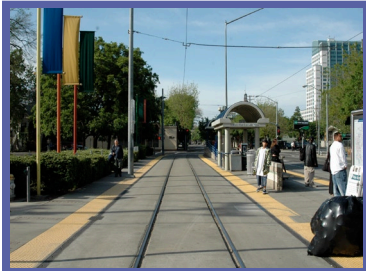
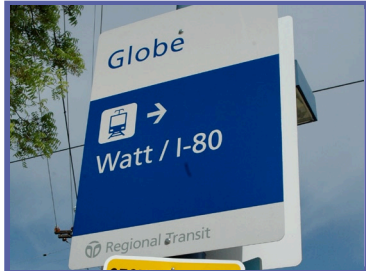
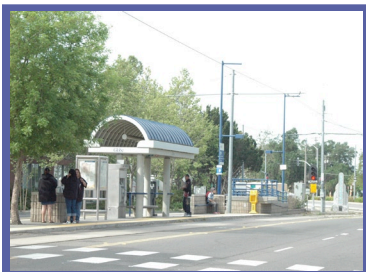
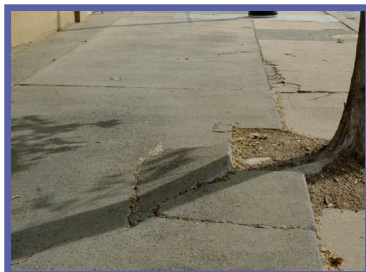
Alkali Flat - Globe  
*Toured on April 27, 2009*

*The Alkali Flat station is shown on the top four images, Globe on the bottom four. Land for TOD surrounds both stations.*

This active, downtown neighborhood station (reviewed here as part of the Blue Line) is surrounded by available land and some outstanding redevelopment opportunities. Because of its heavy use, it is in fair condition.

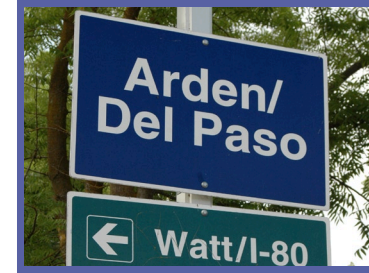
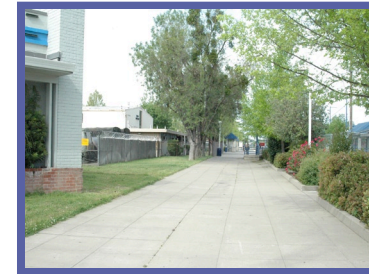
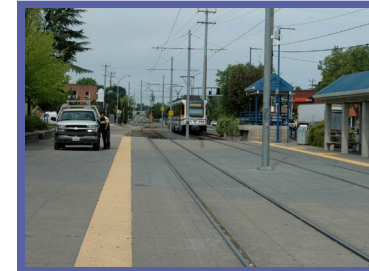
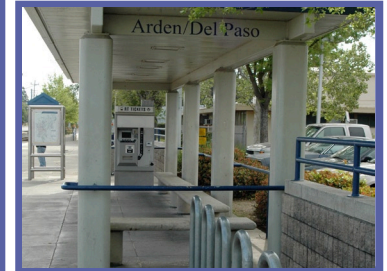
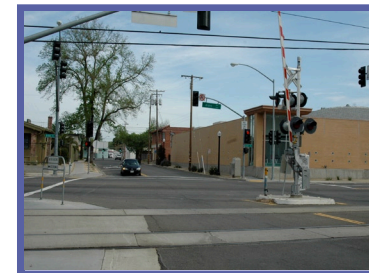
The parking lot was full (only 45 spaces). Strong security presence on the station platform. Tour team had lengthy conversations with security personnel on this leg of the tour, in particular at the Arden/Del Paso station. It sounds like there have been few issues in the past year, but historically the station had a major drug trafficking problem. Given the layout of the station (parking lot, adjacent to a park, etc.) this is conceivable. Finally the ongoing problem of urination and defecation at the station (and on adjacent properties) continues.

All photos above are of the Arden/Del Paso Station. Contrasting images show large pedestrian walkways on portions of the station area (upper left) and encroaching vegetation (bottom right).

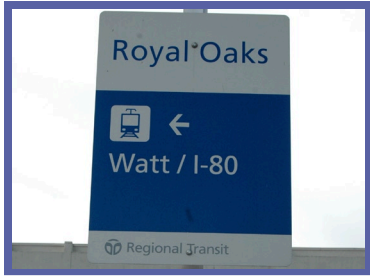
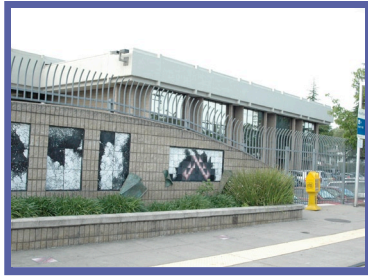
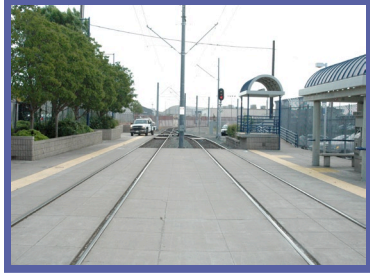
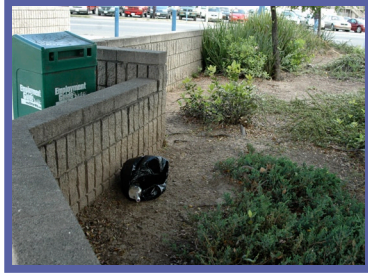
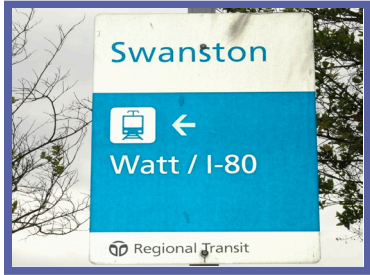
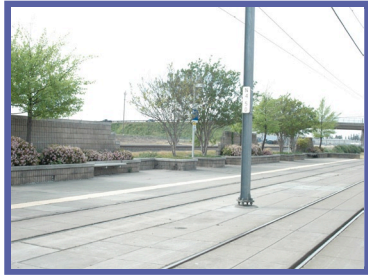
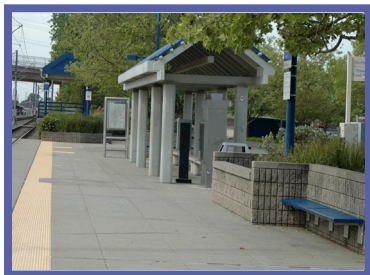
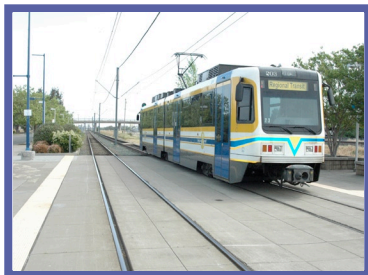
Royal Oaks - Swanston  
*Toured on April 27, 2009*

This small station is ripe for redesign. Only a short distance from the Arden/Del Paso Station, the Royal Oaks Station is adjacent to large offices, federal warehouses and is on the northern edge of the Woodlake community. Some surrounding businesses may be adding to problems (liquor sales, recycling).

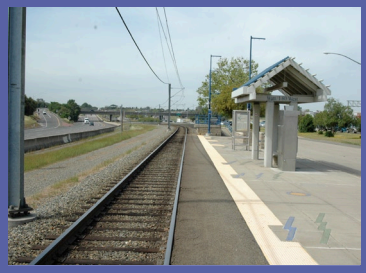
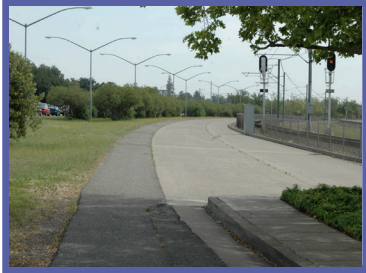
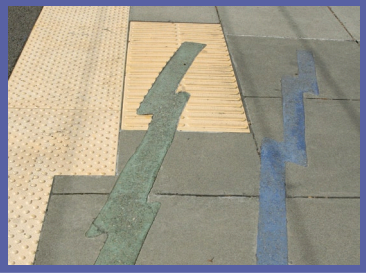
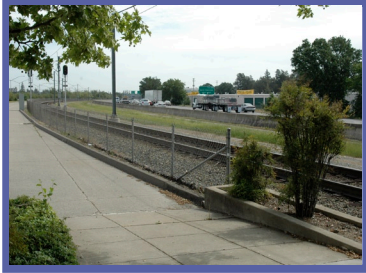
Watt/I-80 West - Watt/I-80

Another commuter (park-n-ride) station with nobody walking to the site. Simple and probably larger than it needs to be, perhaps an inefficient use of space (large expanses of pavement for no apparent reason).

Some cleaning and landscaping work needed at the time of the tour.

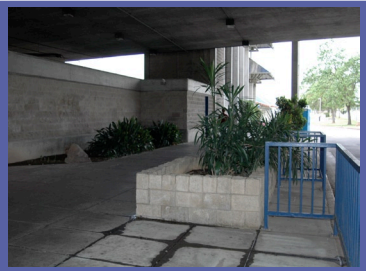
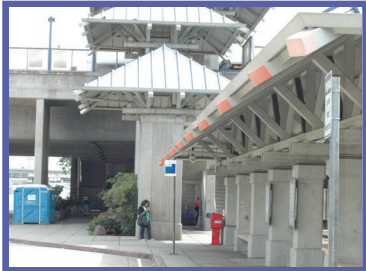
This is the most challenged stations toured on the Blue Line. It has an elevator, connects to 18 bus routes, has (had) a port-a-potty for public use (restroom for security only), flooded planter boxes under the overpass and parking is a good distance from the station.

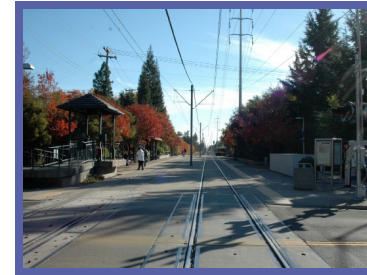
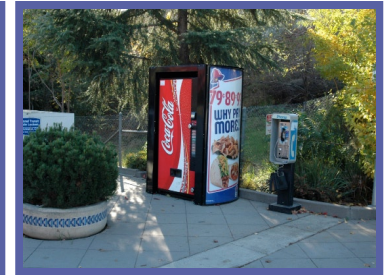
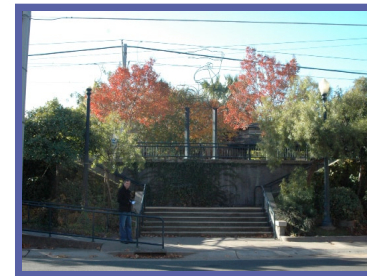
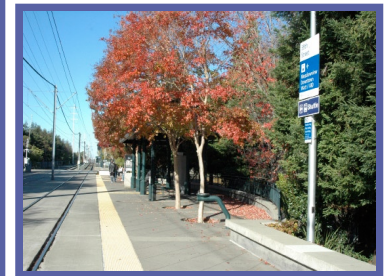
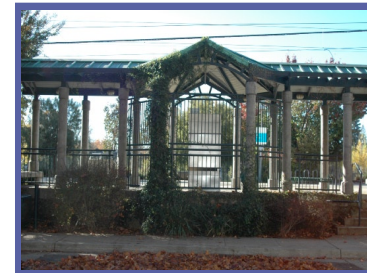
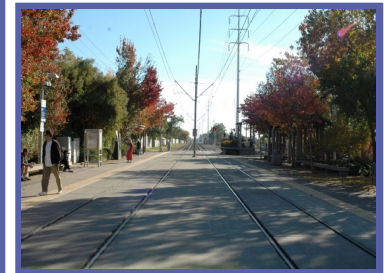
Limited parking in the station area, but there is some (on street). Nice connections to neighborhood. Limited RT info.

*The 39th and 48th Street Stations are some of the prettiest in the system. Surrounded by mature trees and neighborhoods, these are nice places to wait for a train.*

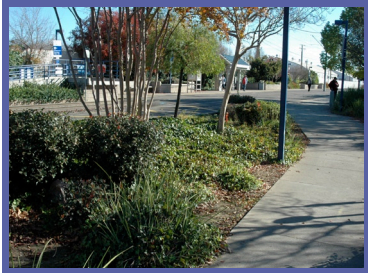
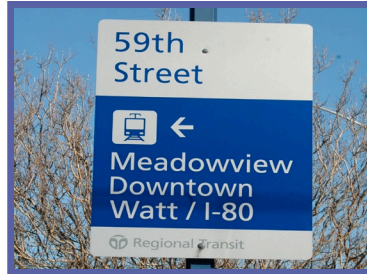
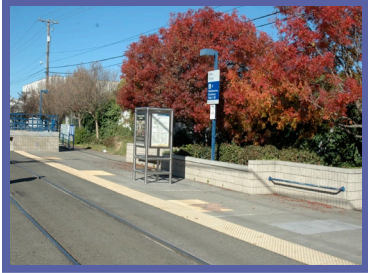
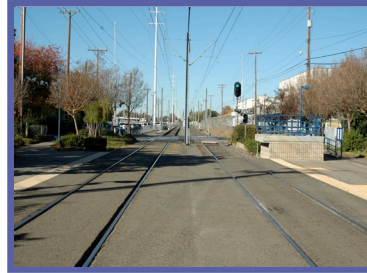
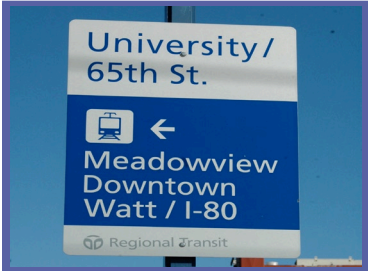
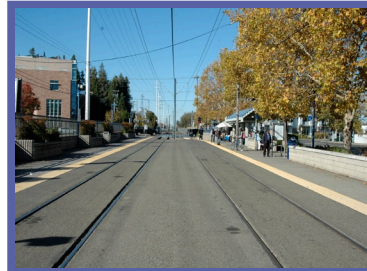
59th Street/University - 65th Street

This quiet station is positioned between the neighborhood and the SMUD facility. Featuring older architecture, this station is simple and pretty plain.

Could be an unsafe station (dark, quiet, hidden). No amenities for riders.

This station is located near office, retail and a neighborhood. Transition to the office (south) is good, Folsom Blvd. presents a safety hazard. Old design (what are those horizontal bars for anyway - middle left photo).

Remove seat walls. Bus lot is bare bones. Support TOD. Lots of pavement needs to be replaced (asphalt).

More shade (covered seating). Fence repairs needed. More bike racks.

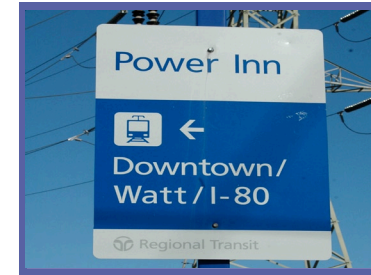
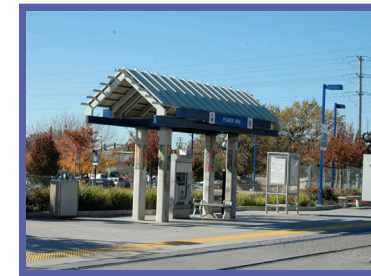
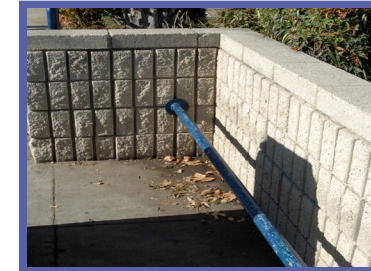
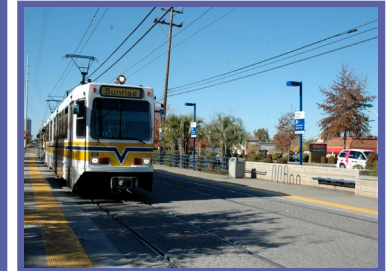
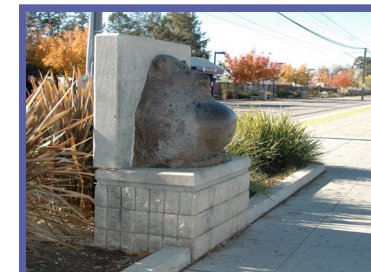
This appears to be a very "average" station. Appearance is okay, surrounding uses okay, fairly well maintained, somewhat active, etc.

*Top four photos show the newer Power Inn Station, with the older College Greens Station below.*

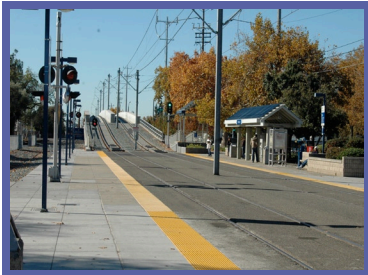
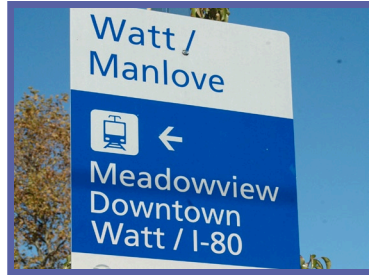
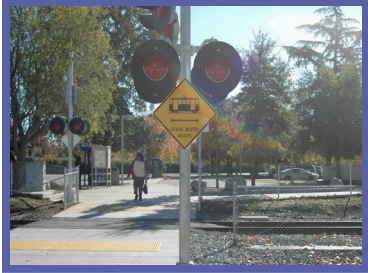
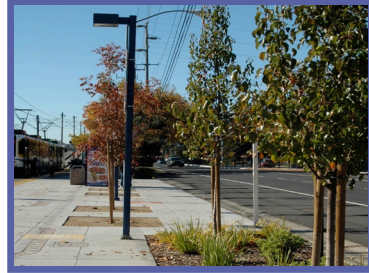
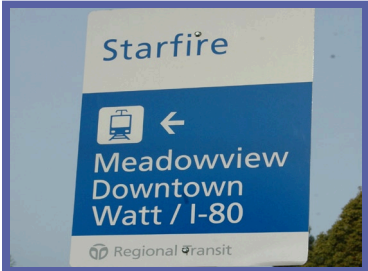
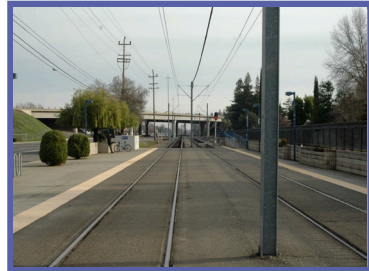
## Watt/Manlove - Starfire

*Typical old planter on bottom left at the Starfire Station. Watt/Manlove Station, above, has new pavement and landscaping.*

No bike racks observed. Minimal security presence (cameras?). Lots of pedestrians on the street (Folsom, etc.). New pavement and plantings.

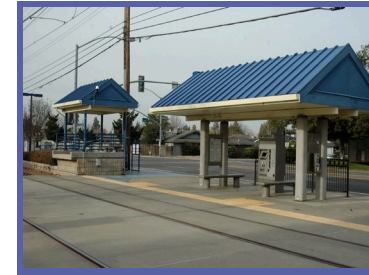
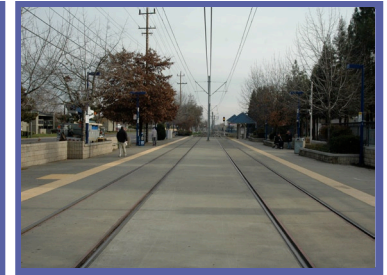
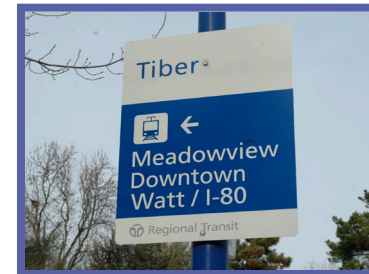
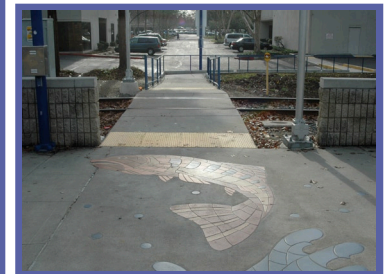
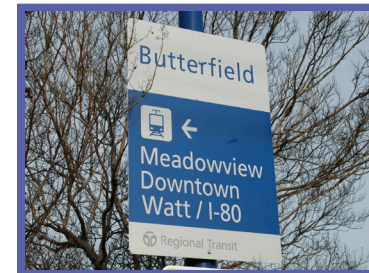
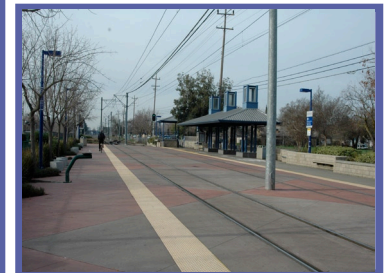
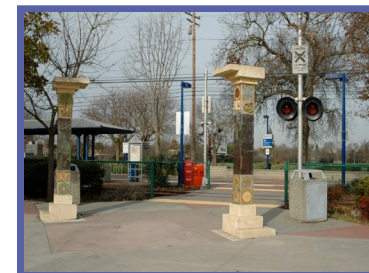
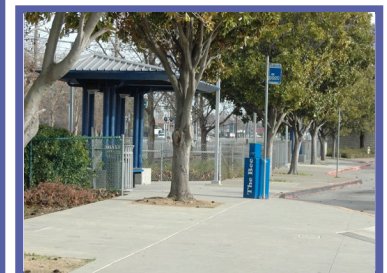
This station is similar to Starfire, same general design...a little more run-down. Less trash, but can was full. Pavement was in good condition (no asphalt, all concrete). Public art is good shape at Tiber.

*Nice entry features at the Butterfield Station, begs the question, is the neighbor (FTB) the reason this station looks and feels so good. The Tiber Station, above four photos, is in good condition, but will need some updating in the coming decade.*

Some vegetation replacement needed.

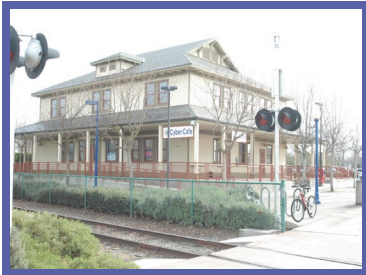
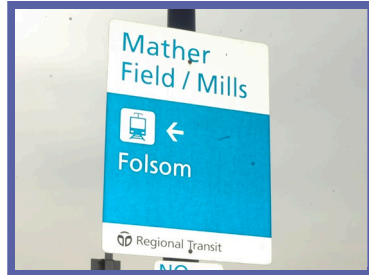
This attractive station is one of the first Rancho Cordova stations in route to Folsom, where clearly the planning staff and electeds have had influence on design and layout.

Broken water faucet. More racks needed. Public art here? More trees.

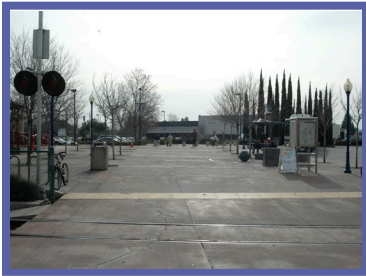
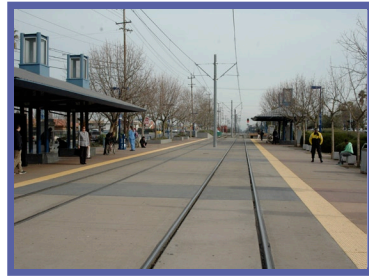
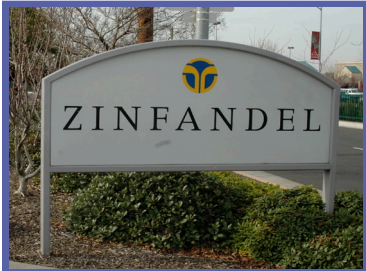
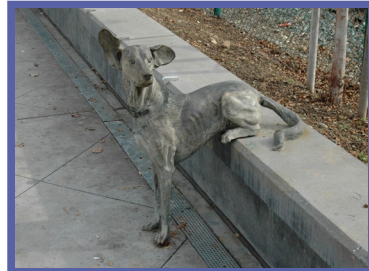
Nice station with some location challenges (that other stations also are saddled with). Attractive stamped concrete with nice shelters and public art are the highlights. City/RT have improved some of the ugly surrounding infrastructure (picture at bottom left - brick electrical shed).

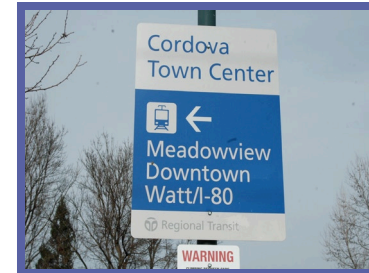
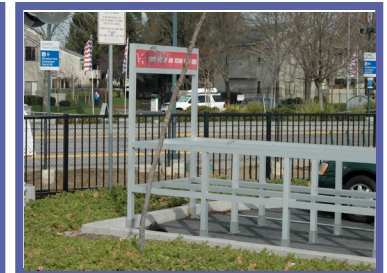
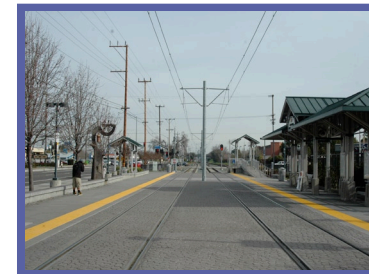
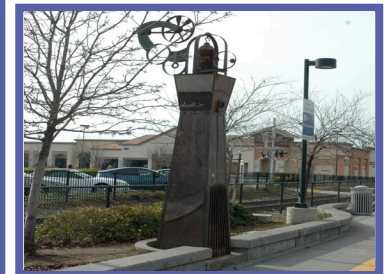
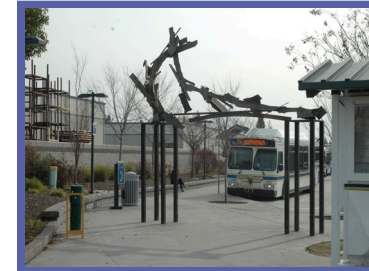
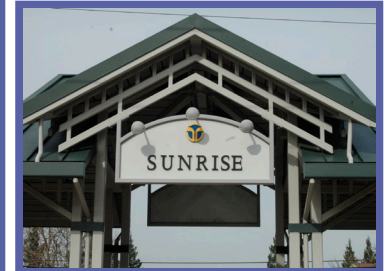
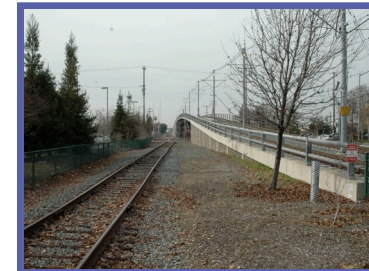
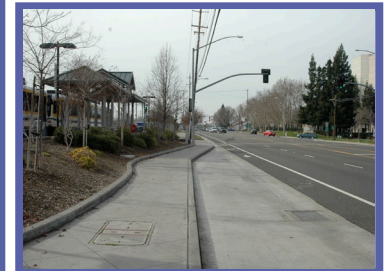
The bottom photos show the LRT bridge over Sunrise Blvd. and the nice interface between the station and Folsom Blvd. Nice structures, landscaping and public art are characteristics of these exemplary stations.

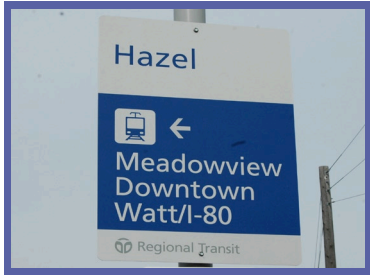
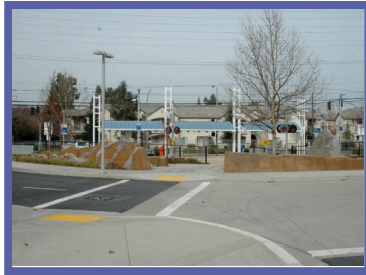
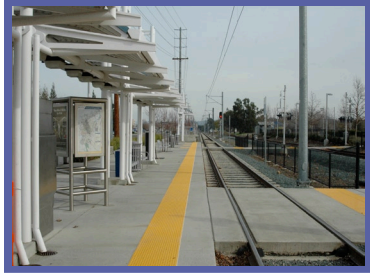
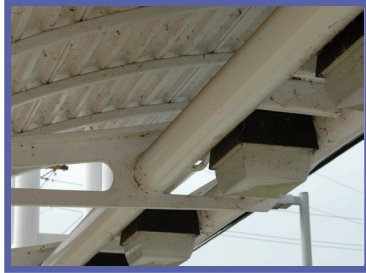
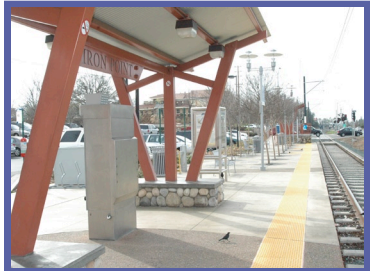
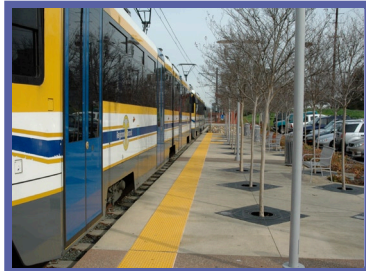
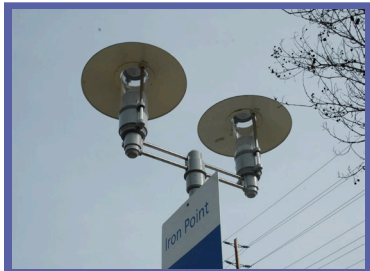
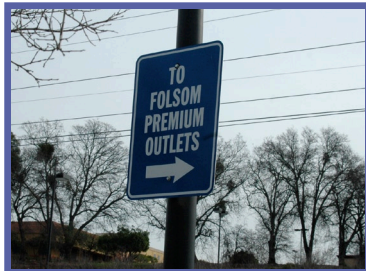
The bottom four photos show the Iron Point Station and how it connects to the area (and retail center). Top four photos show the Hazel Station, including the shelter (second from top, on the right) with its cobbwebs.

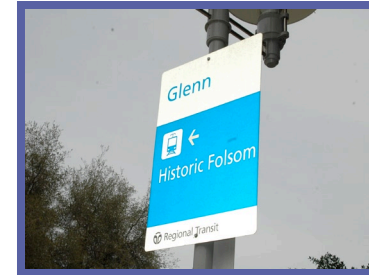
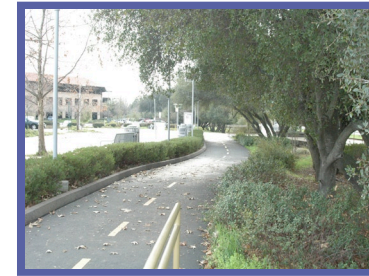
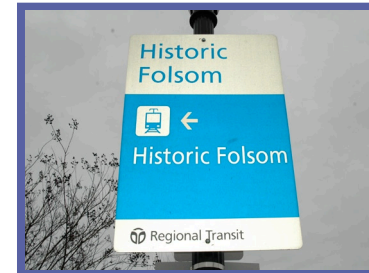
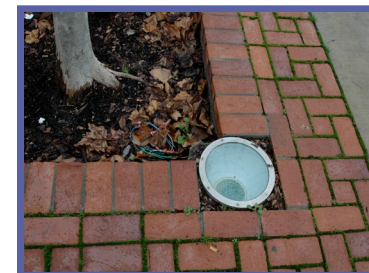
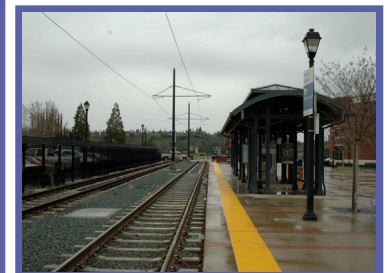
*Pretty nitpicky to point out the unfinished electrical connections and brick work (bottom left), but there is little to criticize at the Historic Folsom Station. The Glenn Station speaks for itself (top four photos).*
